# *KMB Home Inspections* *LLC*

Somewhere In Florida  
Saint Augustine,

Prepared for: Sample Report

Prepared by: KMB Home Inspections, LLC  
297 Pintoresco Dr  
St Augustine , Florida 32095

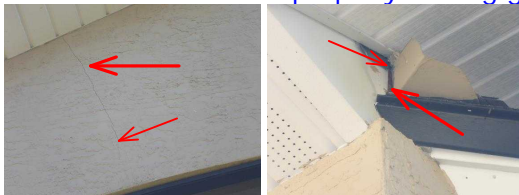
1. Marginal Type: Stucco - **Crack over rear lanai on gable. Recommend sealing.**  
**One area that has exposed framing at kick out flashing on back of home, above bay window. Recommend properly sealing gap on backside of flashing.**

1. Whole house Exterior Surface Type: Stucco - Crack over rear lanai on gable. Recommend sealing. One area that has exposed framing at kick out flashing on back of home, above bay window. Recommend properly sealing gap on backside of flashing.

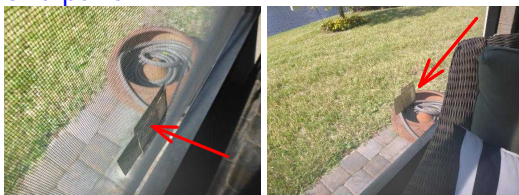
2. Acceptable Fascia: Vinyl
3. Acceptable Soffits: Wood
4. Acceptable Door Bell: Hard wired
5. Acceptable Entry Doors: Fiberglass
6. Acceptable Patio Door: Metal sliding
7. Acceptable Windows: Vinyl single hung
8. Marginal Window Screens: Vinyl mesh - **One hole in screen on lanai, recommend replacing screen in one panel.**

2. Window Screens: Vinyl mesh - One hole in screen on lanai, recommend replacing screen in one panel.

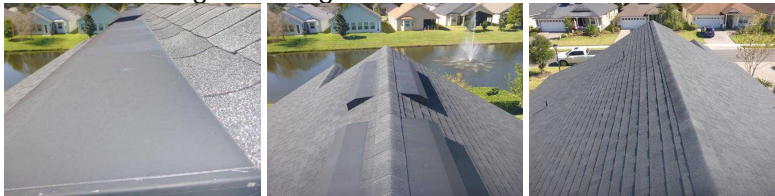
1. Method of Inspection: On roof
2. Acceptable Material: Fiberglass shingle

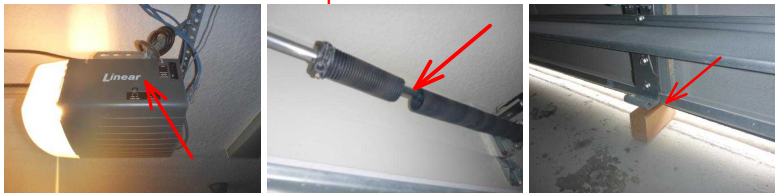
1. Type of Structure: Attached Car Spaces: 2
2. Acceptable Garage Doors: Metal
3. Acceptable Door Operation: Mechanized
4. Defective Door Opener: Linear - **Torsion spring on door is broken and needs replacing. Pressure reverse mechanism is not functioning at time of inspection. This is a major safety issue and could result in personal injury. A licensed garage door contractor is recommended to evaluate and estimate repairs**

1. Attached Garage Door Opener: Linear - Torsion spring on door is broken and needs replacing. Pressure reverse mechanism is not functioning at time of inspection. This is a major safety issue and could result in personal injury. A licensed garage door contractor is recommended to evaluate and estimate repairs

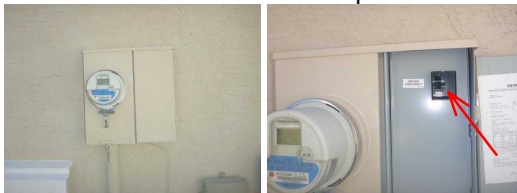
9. Maximum Capacity: 200 Amps
10. Acceptable Main Breaker Size: 200 Amps - Located at meter on side of home.

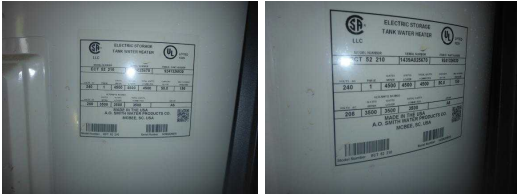
6. Acceptable Water Heater Operation: Adequate
7. Manufacturer: A.O. Smith
- 8.
